CONTAINMENT LINER CORROSION

Darrell Dunn, April Pulvirenti, and Paul Klein

US Nuclear Regulatory Commission
Washington, DC

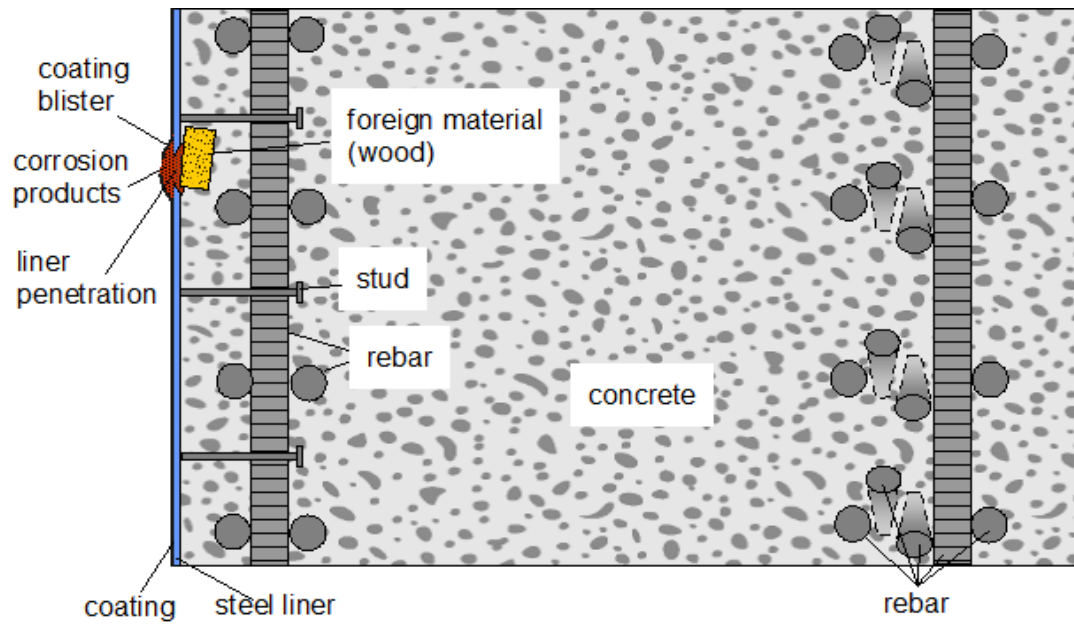
Corrosion initiated at the concrete/liner interface associated with construction defects such as embedded foreign materials appears to be consistent with localized corrosion processes such as pitting corrosion or crevice corrosion. A schematic of liner corrosion initiated as a result of wood embedded in the concrete and in contact with the liner is shown in Figure 1. The effects of embedded foreign material are likely dependent on a variety of factors including the composition, size, and location of the foreign material. In the absence of aggressive contaminants such as chlorides, carbon steel is passivated when exposed to the alkaline environment of concrete. Wood, which has been identified as contributing to the steel containment liner exterior corrosion incidents at D.C. Cook Unit 2, Brunswick Unit 2, North Anna Unit 2 and Beaver Valley Unit 1, is naturally acidic¹⁴ and may also trap sufficient moisture for corrosion reactions.

Figure 1. Schematic of a reinforced containment cross-section showing embedded foreign material and containment liner corrosion

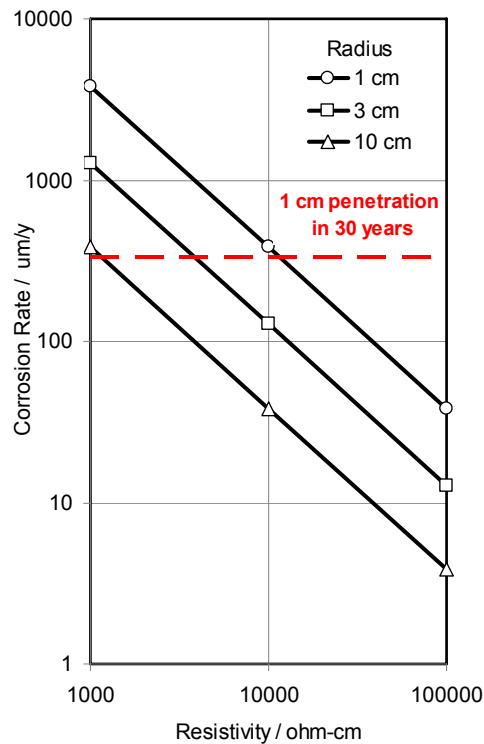
Full wall penetration of a representative 1 cm thick liner over a service time of 30 years was predicted for all anode sizes if the lowest resistivity case ($1 \text{ k}\Omega\text{-cm}$) is considered (Figure 2). Such a condition is reasonable in water saturated concrete scenarios. Even when assuming a value as high as $10 \text{ k}\Omega\text{-cm}$, corrosion penetration within the service life range of interest appears plausible if small anodes were to develop or if the driving potential were larger.

Figure 2. Calculated containment liner macrocell accelerated localized corrosion rate as a function of concrete resistivity and radius of the anodic area.
